Washington County, Oregon

Department of Land Use and Transportation
Operations and Maintenance Division

*Report on Quality Assurance Oversight
In-House Surface and Culvert Projects 2007*

Gerry Douglas Road Management Associates, LLC

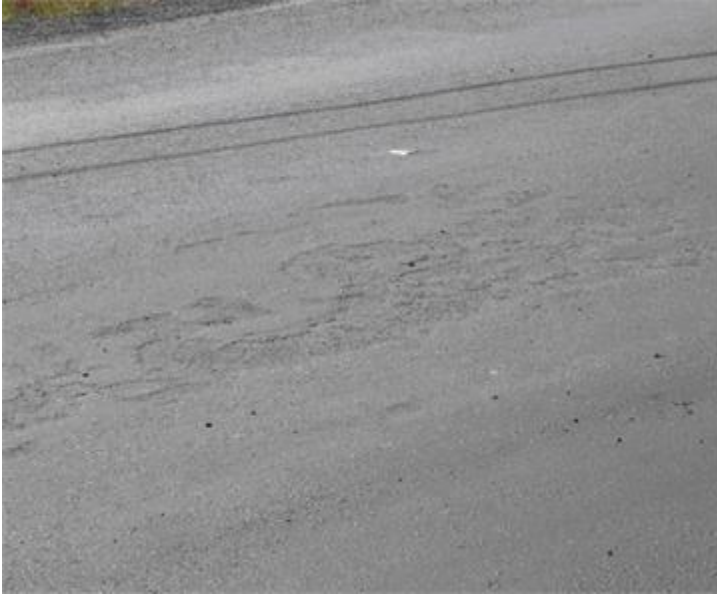
Clark Hill Road near Tile Flat Rd. 7/11/07

3.4.1 On July 10, Clark Hill Road, which was chip sealed during 2006, began having surface bleeding problems, and the road required heavy sanding in the afternoon. As a result, the oil mat picked up in a number of places and was permanently damaged. RMA was informed of the problems and looked at the road July 11.

The surface bleeding is a condition in which oil softens and flows up over the top of the rock that was placed on the oil. There were a number of conditions that could have contributed to the problem July 10, including hot weather and heavy laden truck traffic. Some of the roots may have occurred when the last chip seal was placed. No other roads sealed in 2007 seemed to have experienced this problem. This road is discussed further in Appendix C.

Consideration should also be given to whether chip sealing is the right maintenance solution for this road. A better possibility might be to periodically machine patch this and other areas where heavy truck traffic combined with severe turning movements occur.
