Existing Facility Assessment:
Washington County Fair Complex
February 13, 2009
Updated - February 26, 2018

Main Exhibit Hall

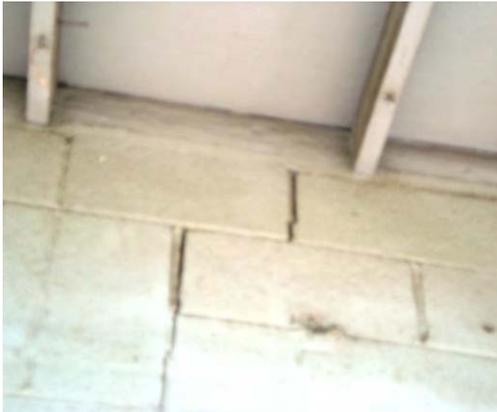
1.01

Cracks in the unreinforced concrete masonry unit wall exist at both interior and exterior of the building.

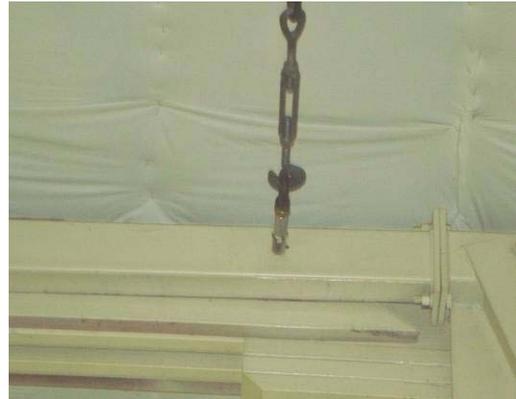
1.02

Cable collar ties installed to truss system in an effort to stabilize wall movement.

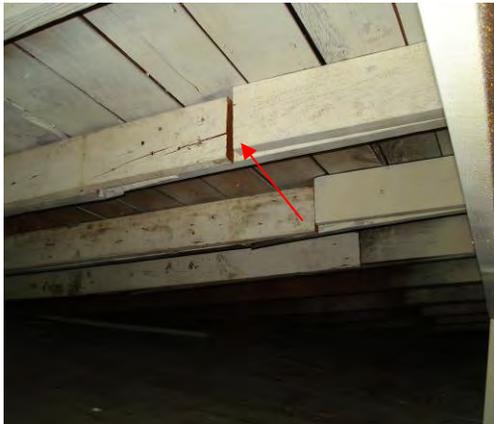
1.03

"Sistering" at roof joists. Note cracking and twisting in repair joist.

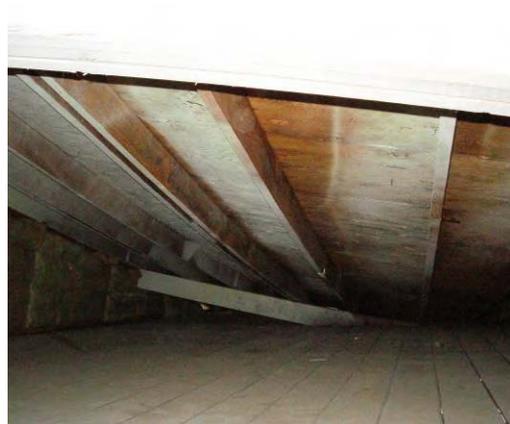
1.04

2" x 6" joists are spaced every 24" and span well over the recommended 8'-10' length, causing significant deflection.

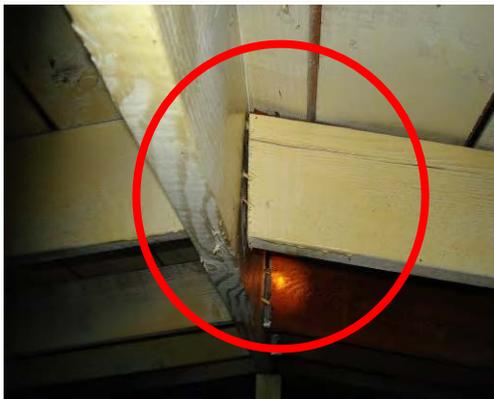
1.05

Joists toenailed into the ridge beam are detaching due to building movement.

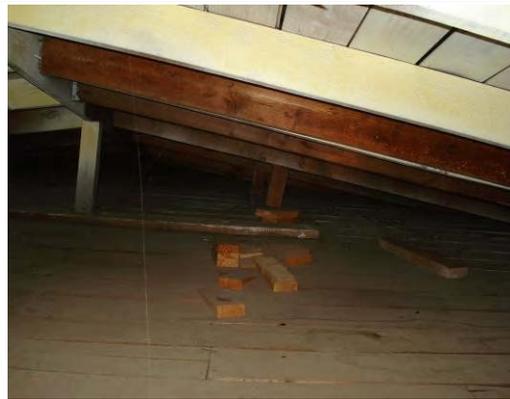
1.06

Note random wood pieces stacked below roof support posts.

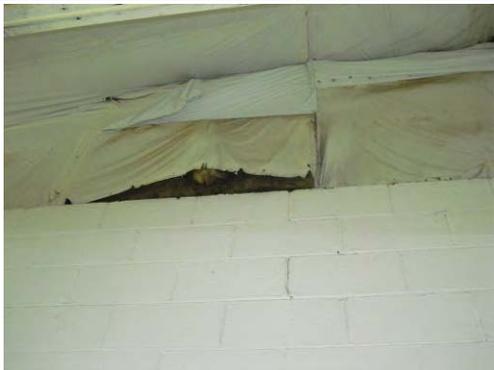
1.07

Detaching vapor retarder reveals moldy and water stained insulation at roof to wall junction.

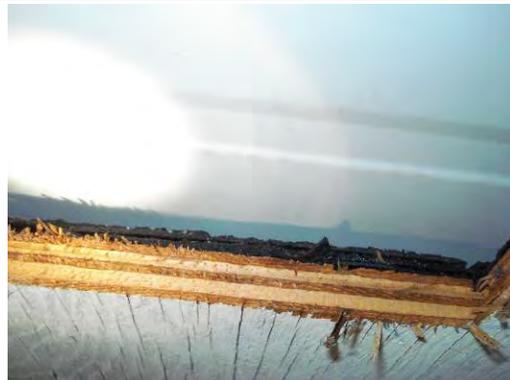
1.08

Unrepaired hole in plywood sheathing where roof support post previously existed. Note presence of asphalt shingles.

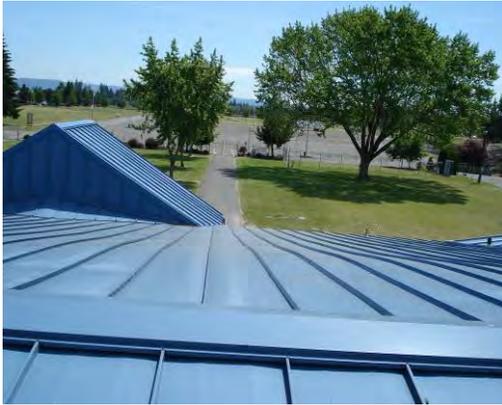
1.09

Wavy appearance in roof panels suggest joist deflection.

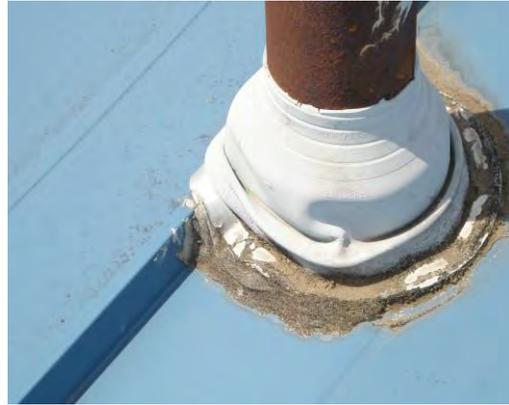
1.10

Vent pipe penetration and pipe boot flashing installed over panel seam. Flashing boot is adhered with sealant and lacks clamping and sealant at top edge.

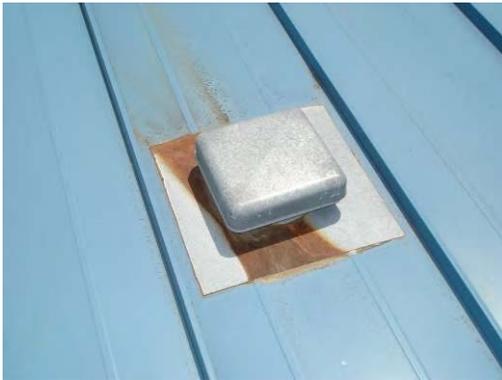
1.11

Flanged vent penetration adhered to panel surface with sealant. Note corrosion from galvanic reaction.

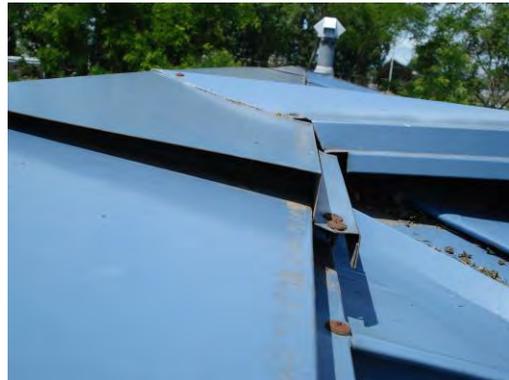
1.12

Raised ridge flashing due to detaching fasteners – south ridge juncture.

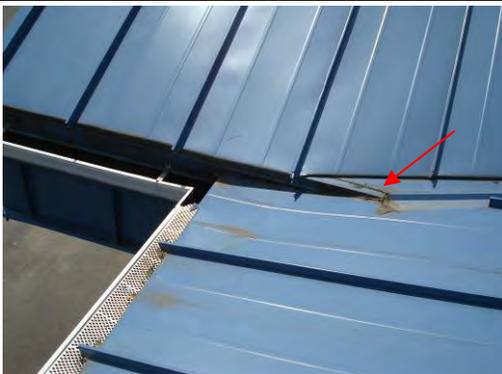
1.13

"Dead" valley, adjacent to leak location at men's room. Note staining on panels where water pools, as well as sealant application on downslope.

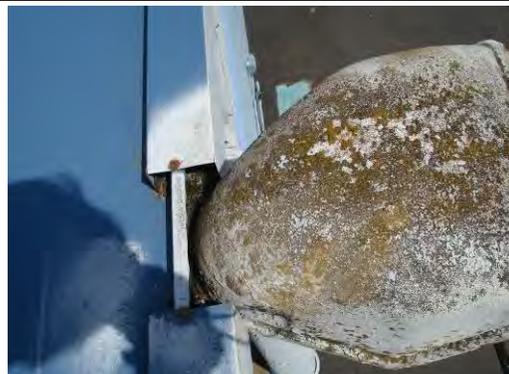
1.14

Open rake flashing where spotlight has been installed, exposing substrate to weather.

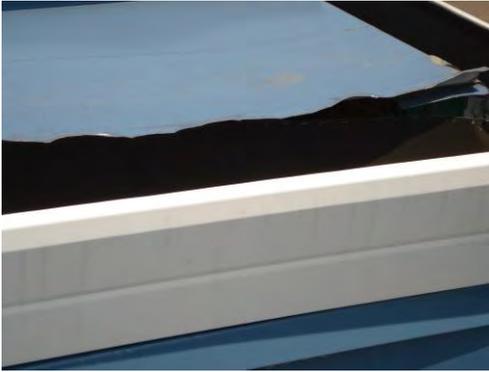
1.15

Missing flashing at gutter section.

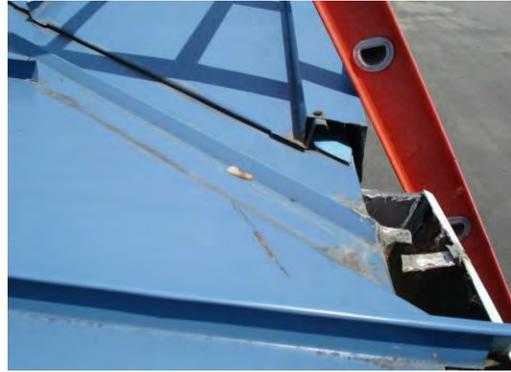
1.16

Broken, detached gutter strap.

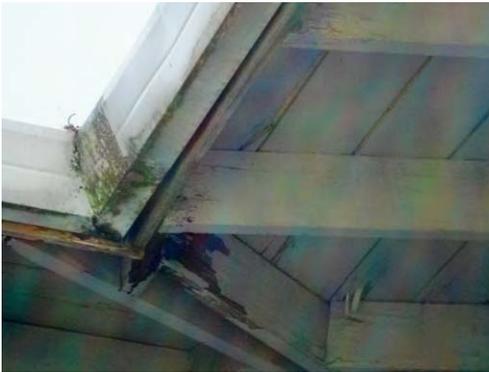
1.17

Leak at gutter seam – note stained, deformed metal and rotten wood adjacent.

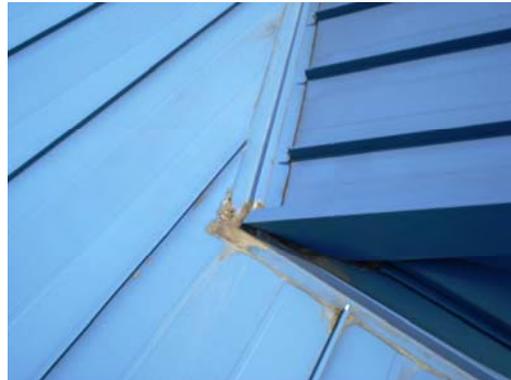
1.18

Sealant dependant cricket-to-roof connection at entrance roof.

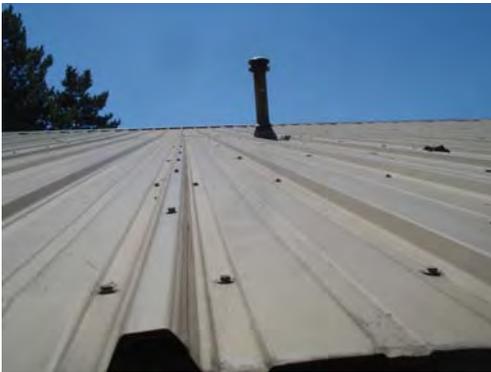
1.19

Multiple fasteners exist throughout the roof system, inhibiting the panels' ability to expand and contract.

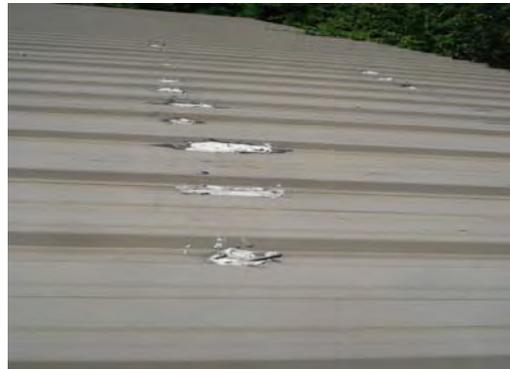
1.20

Most likely an attempt to stop water from penetrating fastener holes, sealant has been applied over fastener heads at various locations.

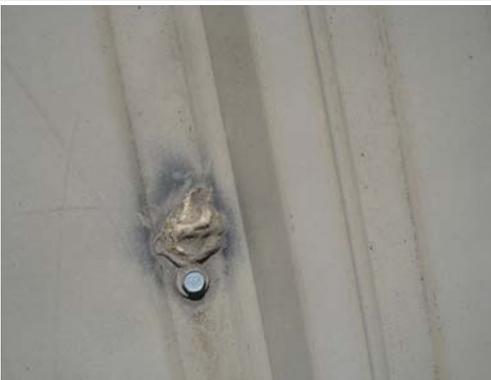
1.21

Water staining around sealed fastener head.

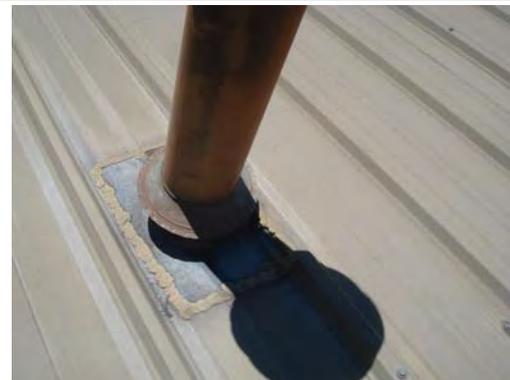
1.22

Sealant-dependant pipe flashing and corroded pipe penetration.

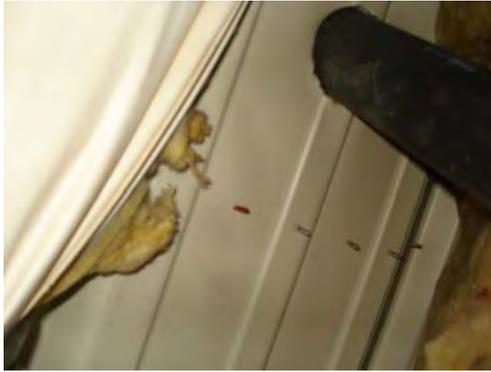
1.23

Corroded fasteners as seen from below the roof panel

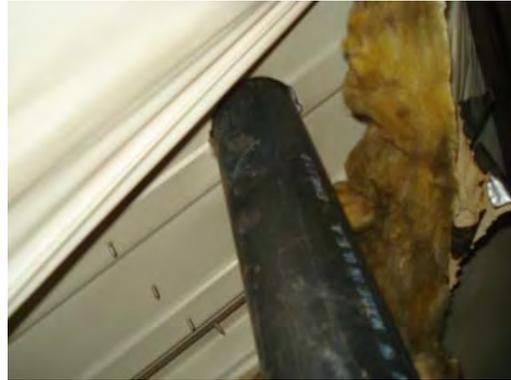
1.24

Water stained batt insulation at vent pipe penetration.

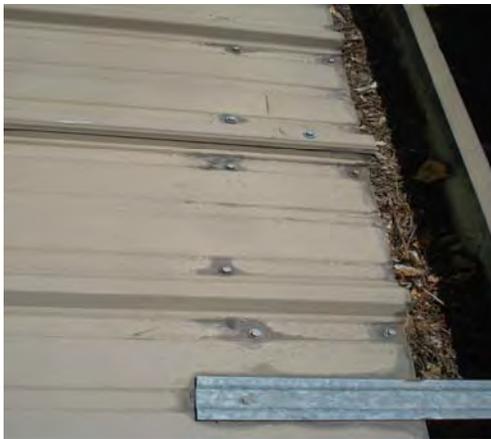
1.25

Gutter straps fastened through the roof panel. Note also excessive organic debris within gutter.

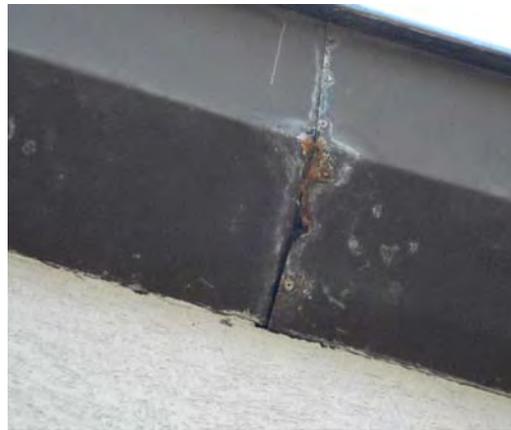
1.26

Wall finish installed flush with bottom of gutter. Note leaking gutter seam at this location.

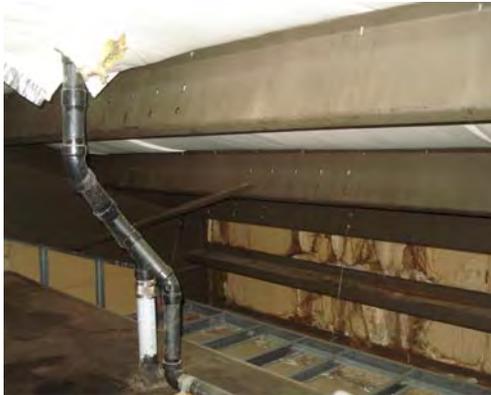
1.27

Stained and damaged wall sheathing as seen from attic space – south wall.

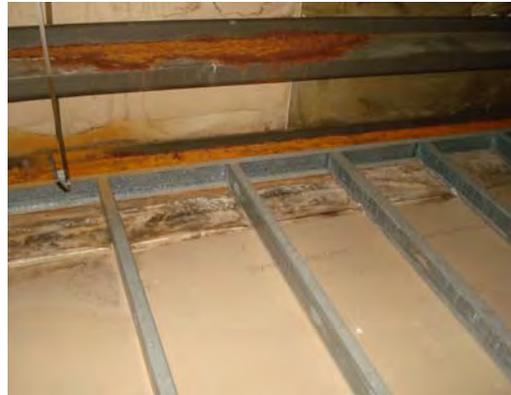
1.28

South wall – note water staining on wall and floor as well as corroded steel framing.

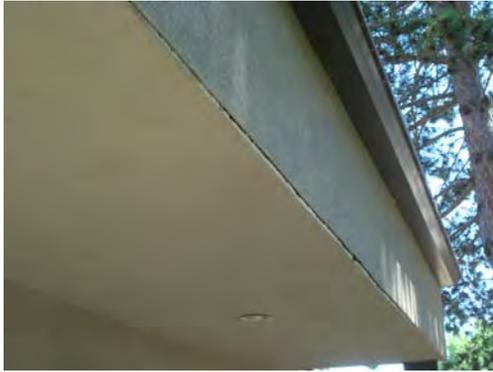
1.29

Exterior view of south wall overhang and soffit. Note soffit panel is warped and detaching from vertical wall.

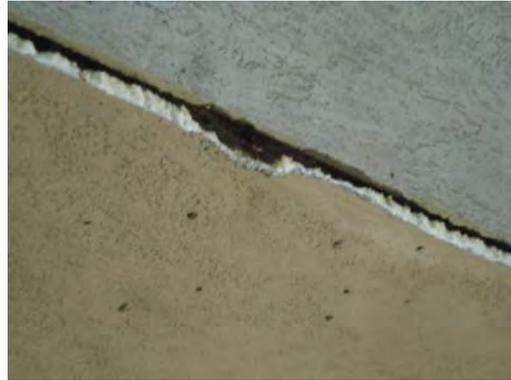
1.30

Close-up view of detaching soffit panel at south wall overhang.

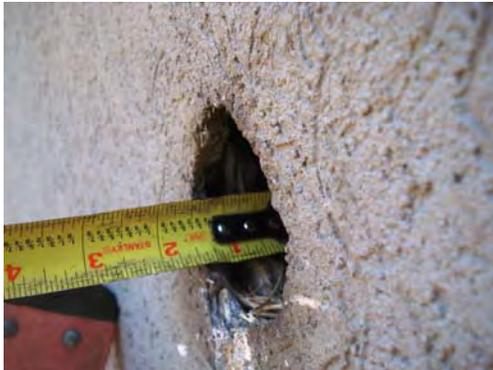
1.31

Hole through wall system at east side of building. This cavity currently serves as a bird house.

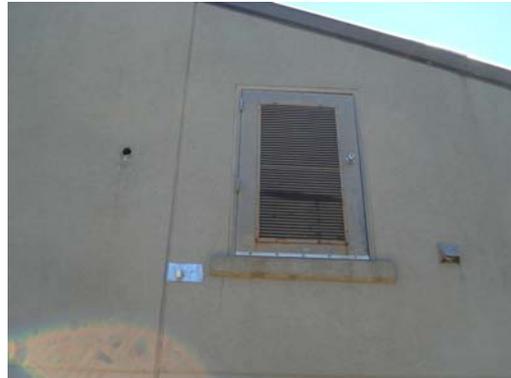
1.32

Note rusted door framing members at attic access location – east wall.

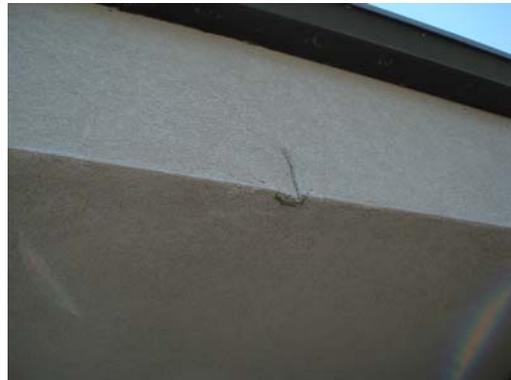
1.34

Damage to wall system at front entrance.

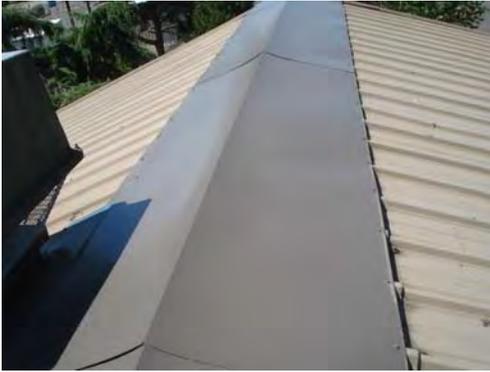
1.35

Lapped, sealant-dependant ridge flashing. Sealant was noted to be failing at this location.

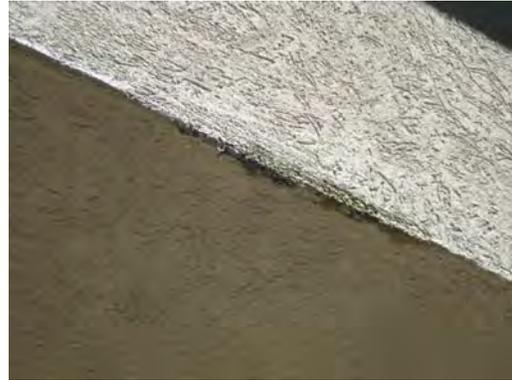
1.36

Algae growth at lower edge of corridor overhang, indicating water exists or has existed within the wall system.
