Washington County, Oregon

Department of Land Use and Transportation
Operations and Maintenance Division

*Report on Quality Assurance Oversight
In-House Surface and Culvert Projects 2007*

Gerry Douglas Road Management Associates, LLC

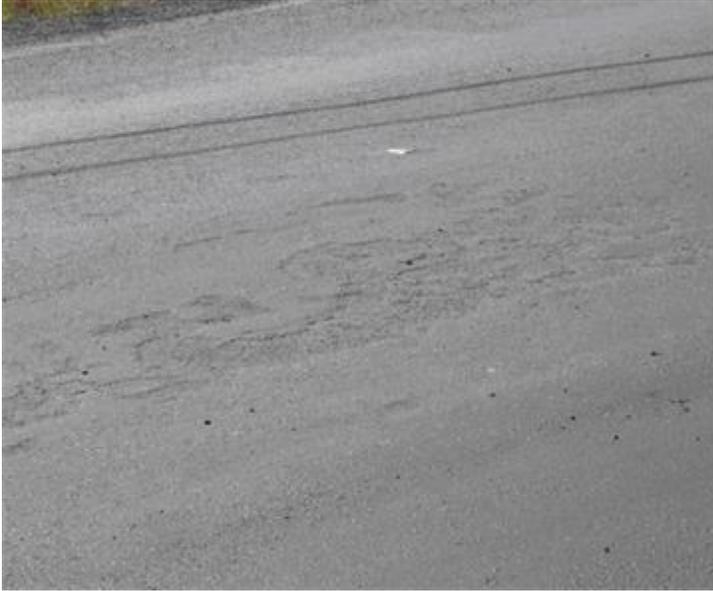
3.4.1 On July 10, Clark Hill Road, which was chip sealed during 2006, began having surface bleeding problems, and the road required heavy sanding in the afternoon. As a result, the oil mat picked up in a number of places and was permanently damaged. RMA was informed of the problems and looked at the road July 11.

The surface bleeding is a condition in which oil softens and flows up over the top of the rock that was placed on the oil. There were a number of conditions that could have contributed to the problem July 10, including hot weather and heavy laden truck traffic. Some of the roots may have occurred when the last chip seal was placed. No other roads sealed in 2007 seemed to have experienced this problem. This road is discussed further in Appendix C.

Clark Hill Road near Tile Flat Rd. 7/11/07

Consideration should also be given to whether chip sealing is the right maintenance solution for this road. A better possibility might be to periodically machine patch this and other areas where heavy truck traffic combined with severe turning movements occur.

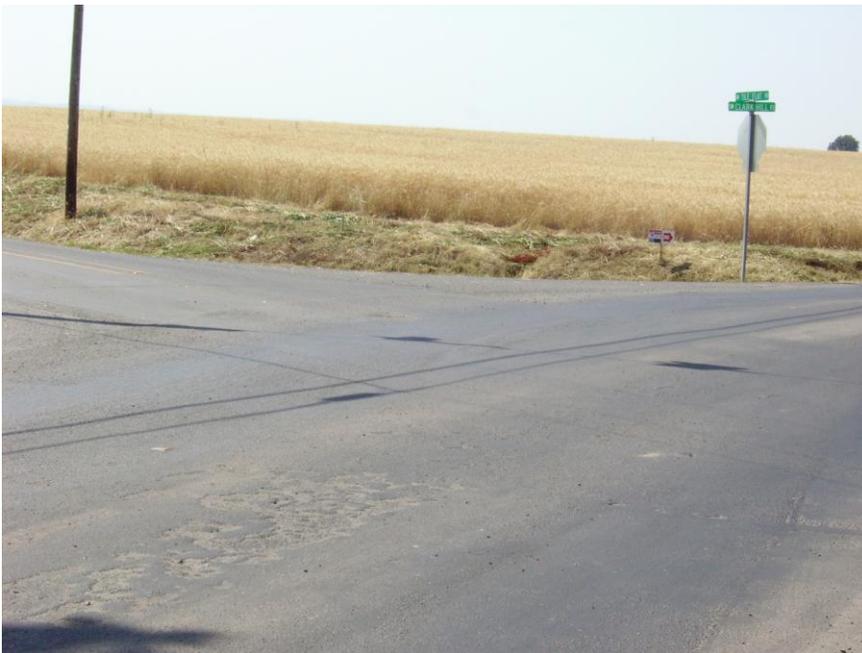
Clark Hill Road at Tile Flat Rd. 7/11/07
