Existing Facility Assessment:
Washington County Fair Complex
February 13, 2009
Updated - February 26, 2018

Main Exhibit Hall

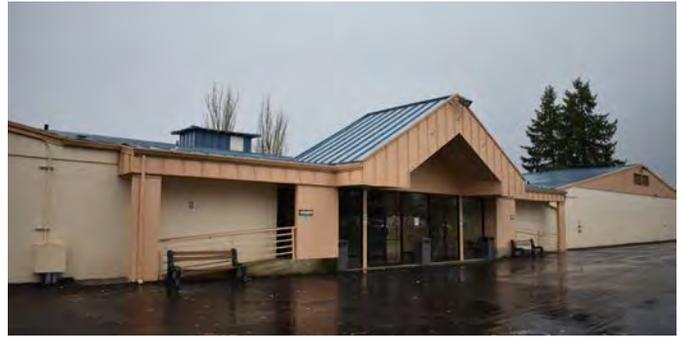
Based on the site visit October 18, 2017, the building appears to be in the same condition as it was in 2009 with minor to no improvements.

Based on our visual investigation, we believe this building represents a severe life safety hazard to the public. Vertical and lateral upgrades to the building, complying with current code requirements, should be implemented prior to its use.

- **Water Infiltration:** Per reports dated July 17, 2008 and Nov 17, 2008, remove existing roof and replace with new standing seam metal roof and replace missing/damaged roof insulation. See Appendix G and H.

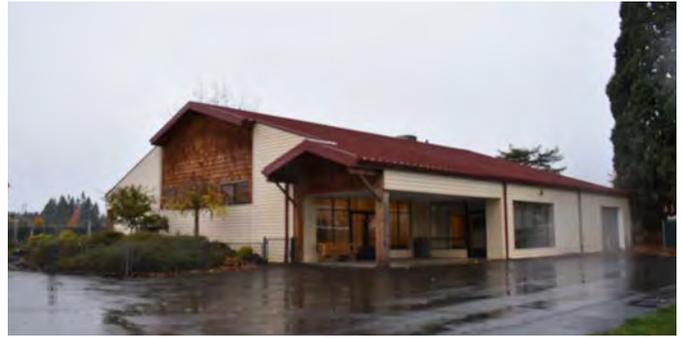
Cloverleaf Community Building

Based on our visual investigation, we believe this building is in good shape however, the interior unreinforced masonry building represents a severe life safety hazard to the public. Lateral upgrades, complying with current code requirements, to this interior building should be implemented prior to its use.

life safety for the interior building, due to out of plane seismic loading. Based upon performance of buildings of this type in prior seismic events we would expect to see several major failures. Such failures are; collapse of unreinforced masonry walls due to a lack of reinforcement and/or proper support at the roof, collapse of headers at exits/doorways, and loss of support of roof members due to these failures.

- Upgrade existing interior emergency egress lighting equipment to provide compliance with Oregon Structural Specialty Code section 1006.
- Revise existing interior power receptacles to comply

with Oregon Electrical Specialty Code article 210. Ground-fault circuit interrupter (GFCI) protection is required at all 15 and 20-amp, 125 volt receptacles in non-dwelling unit kitchens and exterior locations.

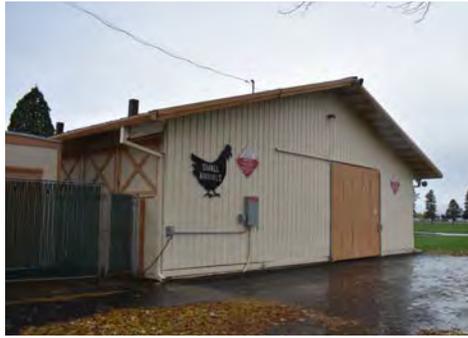
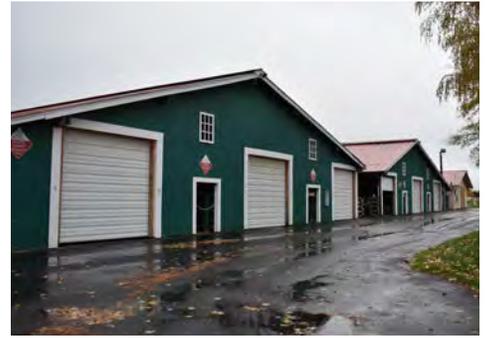
Poultry Barn, 4-H North, and 4-H South

The condition of these buildings varies but is generally good as it relates to the functionality of an agricultural building such as a pole barn. That said, should these buildings be classified for use by the public, vertical and lateral upgrades to current standards would be required.

- Due to large spans, undersized members, poor construction practices, and long term exposure to water which has caused rot to occur in the skip sheathing, roof joists, and columns, we have concerns with the structural integrity of these buildings. In general, we would expect to find that the roof system is over stressed by at least a factor of 2.
- Problematic roof structures between 4H Barns North and South, and 4H Barn North and Poultry, have been removed since the 2009 assessment. Some roof members and poles exhibiting dry rot have been replaced, and some non-structural improvements have been made. Strengthening of lateral force system and gravity systems has not been implemented.

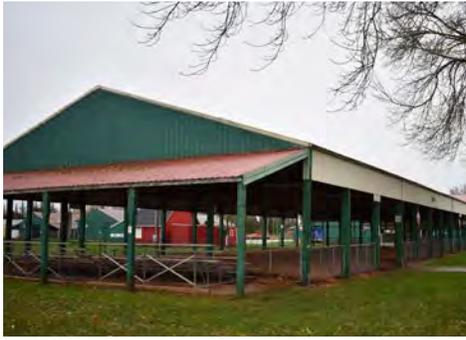
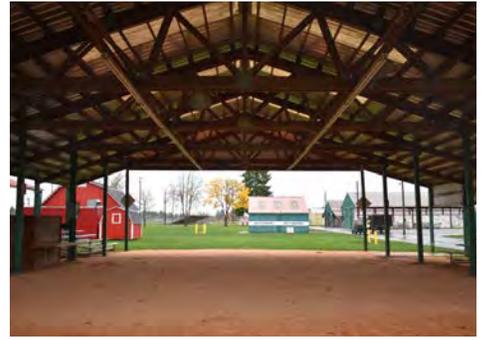
Show Ring and Auction Ring

The condition of these buildings varies but is generally good as it relates to the functionality of an agricultural building such as a pole barn. That said, should these buildings be classified for use by the public, vertical and lateral upgrades to current standards would be required.

These buildings are in fair condition with an estimated useful life of 10 – 15 years.

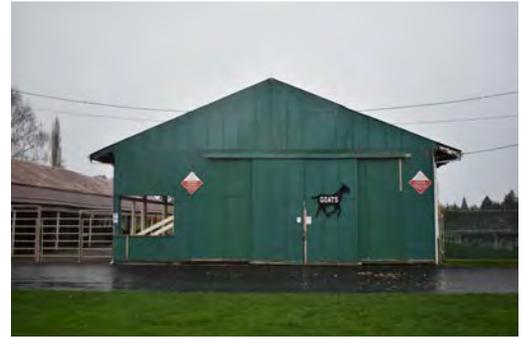
Goat Barn

Based on our visual investigation, we believe this building to be in good condition if classified as an agricultural building but in general non-compliance with current code requirements for a public use classification.

- The condition of this building varies but is generally good as it relates to the functionality of an agricultural building such as a pole barn. That said, should this building be classified for use by the public vertical and lateral upgrades to current standards would be required.
- During our investigation it was also noted that leaks in the roof at multiple locations, and apparently over a consistent period of time, have likely caused rot to occur in the structure.

- **Exiting:** Provide man doors for exiting for barns with walls. Minimum of 2 on opposite ends of the building.
- **ADA Accessibility:** Accessible path of travel through facility.
- **Water infiltration:** The site floods with heavy rains. It is recommended to build up the floor of the building with gravel or asphalt to keep water away from the structural posts and the interior of the building. The roof appears to have multiple leaks and should be repaired or replaced. We also recommend investigation of the condition of the structural poles below grade to verify condition in consideration of the site flooding that may have compromised some of the poles.

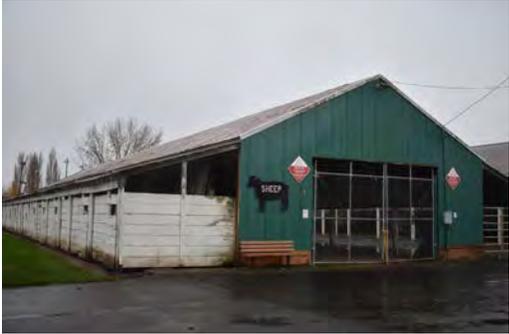
Sheep Barn

Based on our visual investigation, we believe this building to be in poor condition and in general non-compliance with current code requirements for a public use classification.

- During our investigation it was also noted that leaks in the roof at multiple locations, and apparently over a consistent period of time, have likely caused rot to occur in the structure.

- **Exiting:** Provide man doors for exiting for barns with walls. Minimum of 2 on opposite ends of the building.
- **ADA Accessibility:** Accessible path of travel through facility.
- **Water infiltration:** The roof leaks in multiple locations and has caused significant damage to the structure. The roof needs to be replaced and structural repairs made. In addition, the site floods with heavy rains. The flooding needs to be addressed by raising the grade of the building to protect the floor area and the structural posts. This could be accomplished by adding a gravel or asphalt base to keep water away from the building. We also recommend investigation of the condition of the structural poles below grade to verify their condition in

Based on the condition of the building and the on-going water issues, it is our recommendation to remove and replace this building.

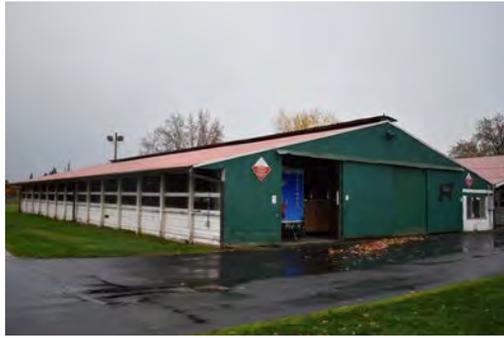
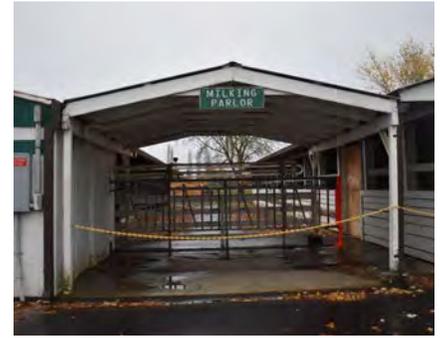
Dairy Barn West, Dairy Barn East, and Milking Parlor

Based on our visual investigation, we believe the milking parlor and adjacent breezeway represent a severe life safety hazard. This building should be torn down or vertical and lateral upgrades, complying with current code requirements, building should be implemented prior to its use.

- We have major concerns for the unreinforced masonry component with respect to collapse, and therefore life safety for this building, due to out of plane seismic loading. Based upon performance of buildings of this type in prior seismic events we would expect to see several major failures. Such failures are; collapse of exterior walls due to a lack of

- **Exiting:** Provide man doors for exiting for barns with walls. Minimum of 2 on opposite sides of the building.
- **ADA Accessibility:** Accessible path of travel through facility.
- **Water infiltration:** The roof added between barns for the milking parlor have interrupted the roof drainage. This coupled with age of roof has caused water infiltration and

damage to the roof framing members. The added roofs need to be removed and structural member assessed for rot or deterioration. Replace leaking roofing, gutters and downspouts.

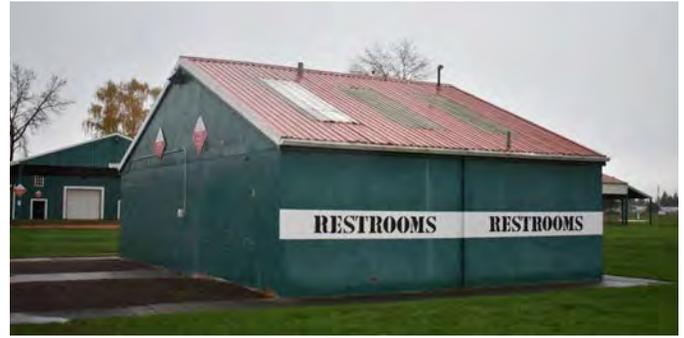
Restroom Building

Based on our visual investigation, we believe this building represents a severe life safety hazard to the public. Vertical and lateral upgrades, complying with current code requirements, to the building should be implemented prior to its use.

- We have major concerns with respect to collapse, and therefore life safety for this building, due to out of plane seismic loading. Based upon performance of buildings of this type in prior seismic events we would expect to see several major failures. Such failures are; collapse of exterior walls due to a lack of reinforcement and/or proper support at the roof, collapse of headers at exits/doorways, and loss of support of roof members due to these failures.

- **ADA Accessibility:** Accessibility within restroom and showers to be addressed; including entrance access, stall size and shower controls.
- **Water infiltration:** Replace downspouts and gutters.

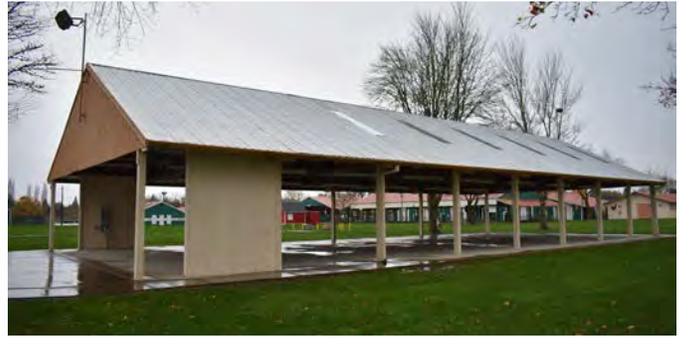
Friendship Hall

Based on our visual investigation, we believe this building to be in good condition if classified as an agricultural building but in general non-compliance with current code requirements for a public use classification.

- During our investigation it was also noted that leaks in the roof at multiple locations, and apparently over a consistent period of time, have likely caused rot to occur in the structure.

- ADA Accessibility upgrades to meet code requirements, including replacing handrails/guardrails and adding accessible access route to stage through a ramp.
- Water infiltration: Replace downspouts and gutters.

- Upgrade area lighting equipment (comprised primarily of 4-foot fluorescent luminaires) to provide compliance with Oregon Electrical Specialty Code (OESC) article 410. This section requires that all luminaires installed in damp location shall be marked "Suitable for Damp Locations."
- Upgrade existing interior emergency egress lighting equipment to provide compliance with Oregon Structural Specialty Code (OSSC) section 1006.
- Revise existing interior power receptacles to comply with Oregon Electrical Specialty Code (OESC) article 210. Ground-fault circuit interrupter (GFCI) protection is required at all 15 and 20-amp, 125 volt receptacles in exterior locations.

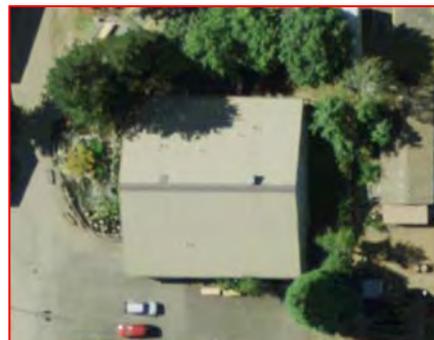
Aerial View – Cloverleaf Bldg.

was completed in 1982). A steel framed building, both EIFS (Exterior Insulated Finish System) and stucco have been used as exterior finishes. The currently installed 14-year old roof is a structural ribbed standing seam, 36" wide metal panel system over metal framing; fiberglass batt insulation and associated vapor retarder are installed below the roof deck between steel purlins. Leaks associated with both the roof and walls have been reported, and water damage was noted at various locations at the time of inspection. The Cloverleaf Building contains exhibit, office and kitchen space.
